*California Department of Transportation
Division of Maintenance*

Structure Maintenance and Investigations

Bridge Number : 10 0136
Facility Carried: STATE ROUTE 1
Location : 01-MEN-001-43.74
City :
Inspection Date : 10/06/2015

STRUCTURE NAME: ALBION RIVER

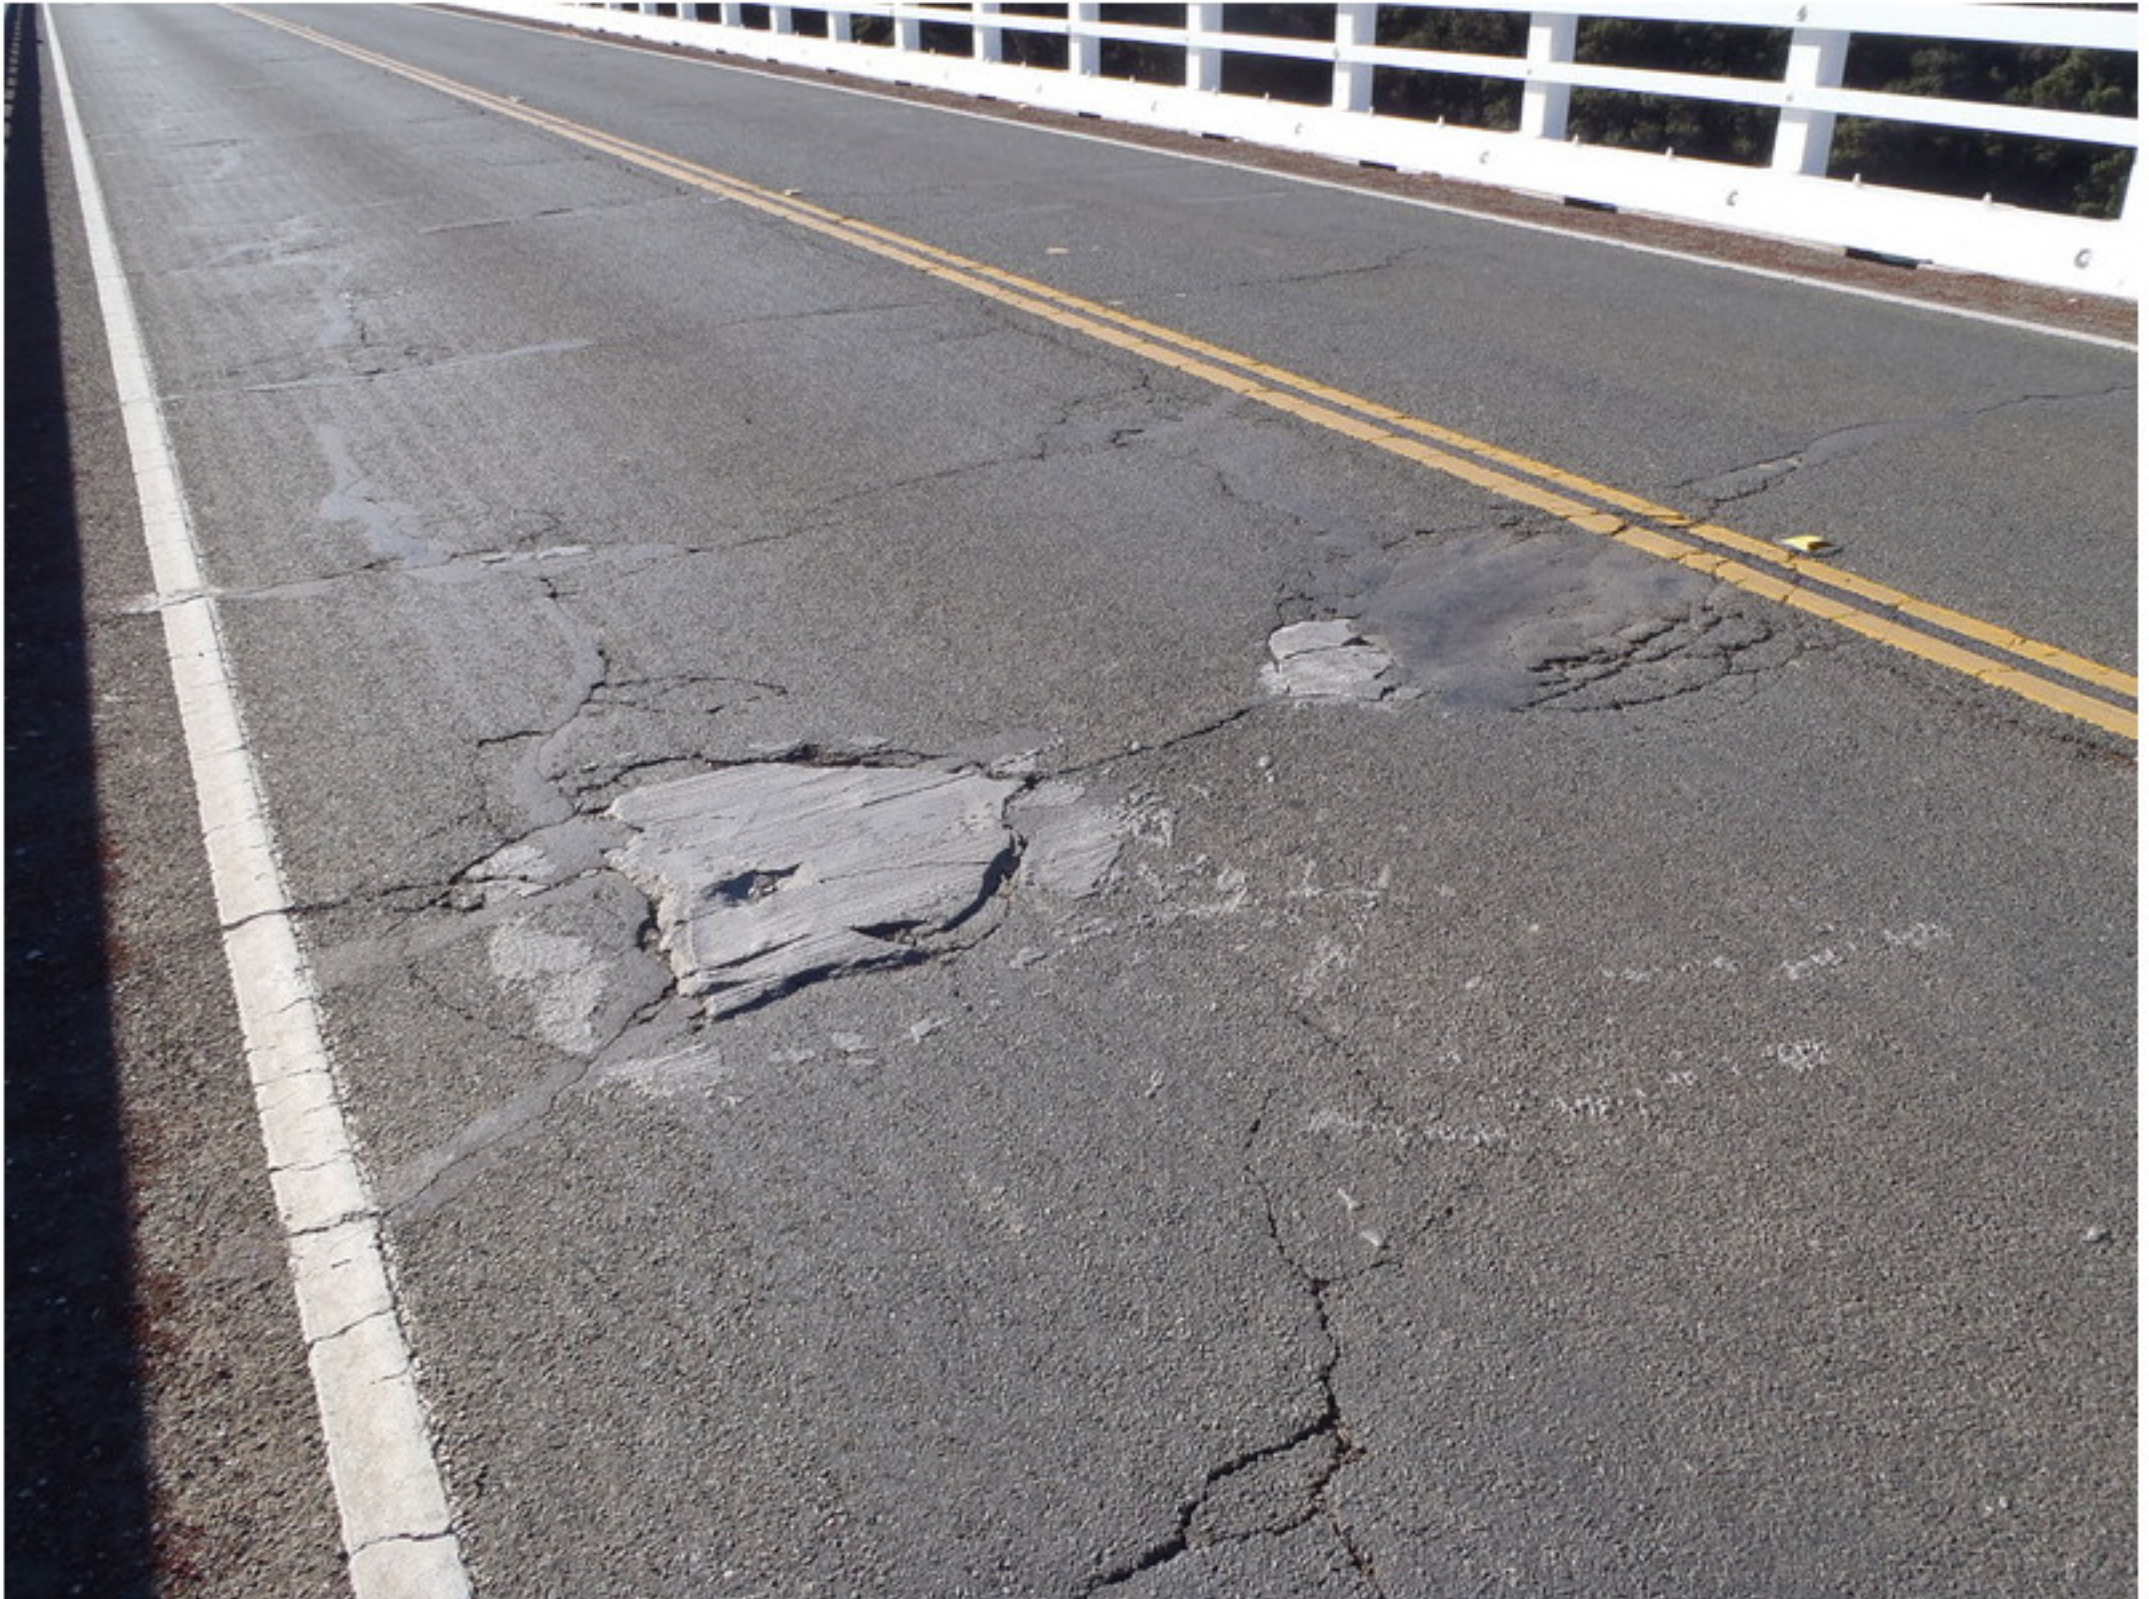
Photo No. 1
Looking south at repaired portion of riding surface of northbound lane over approach span

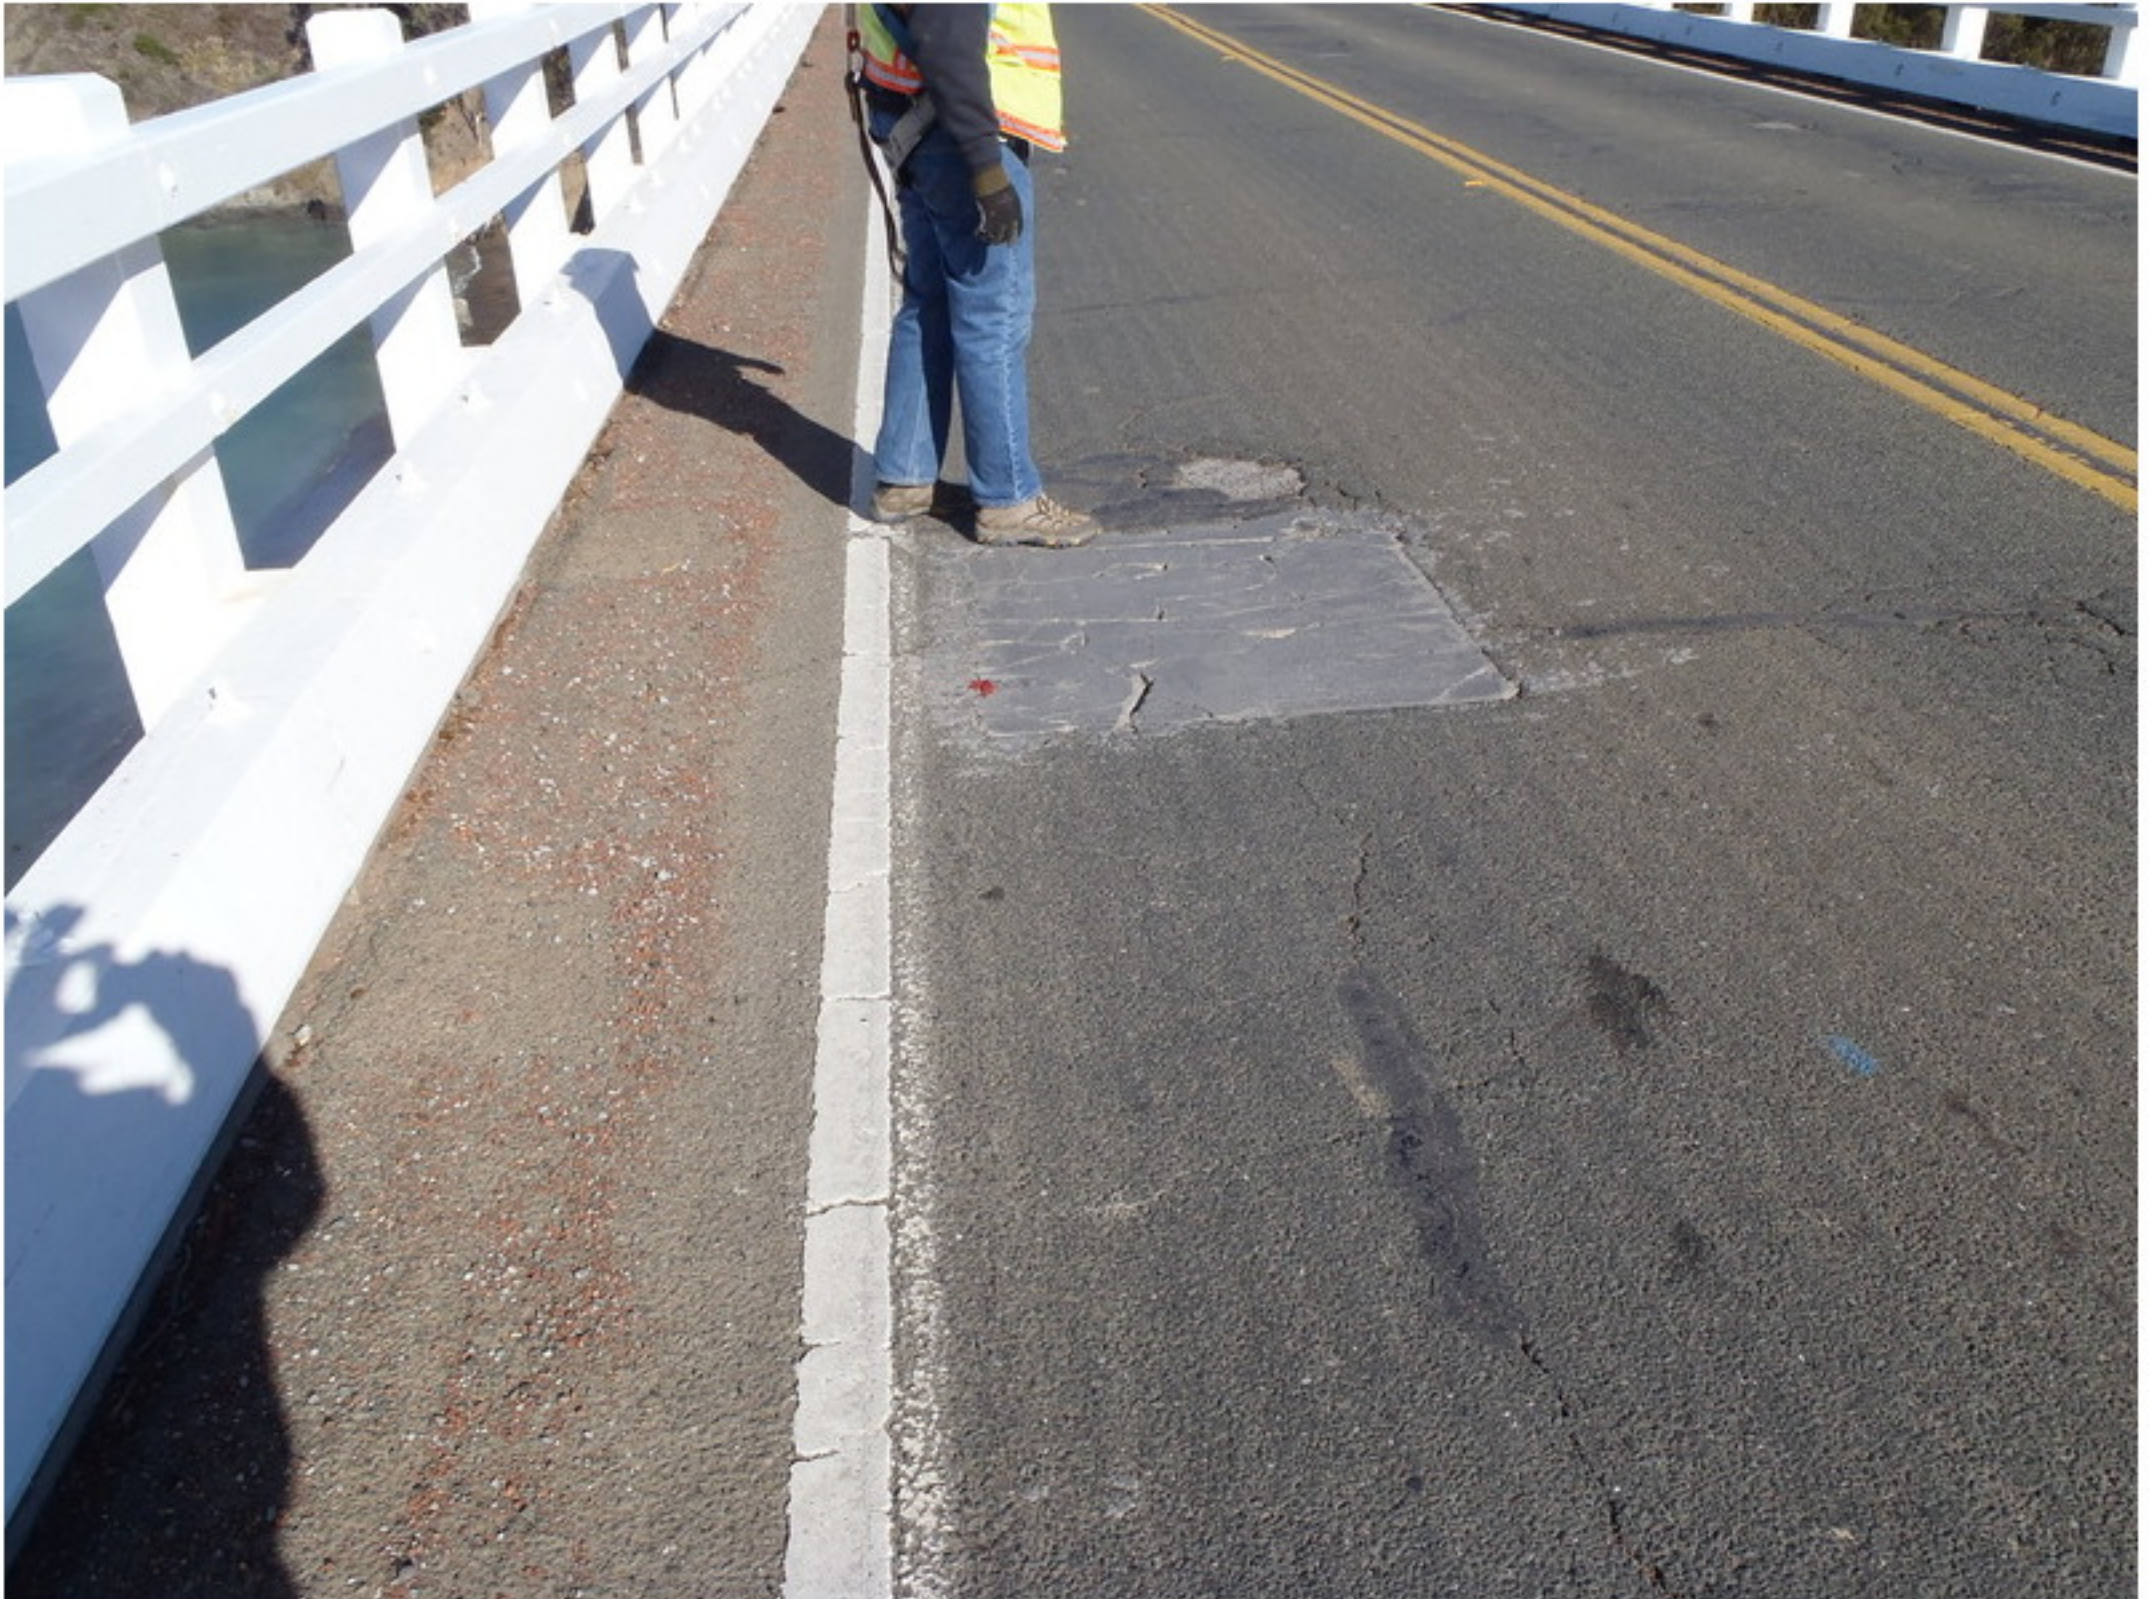
Photo No. 2
Looking north at repaired portion of riding surface of southbound lane over approach span

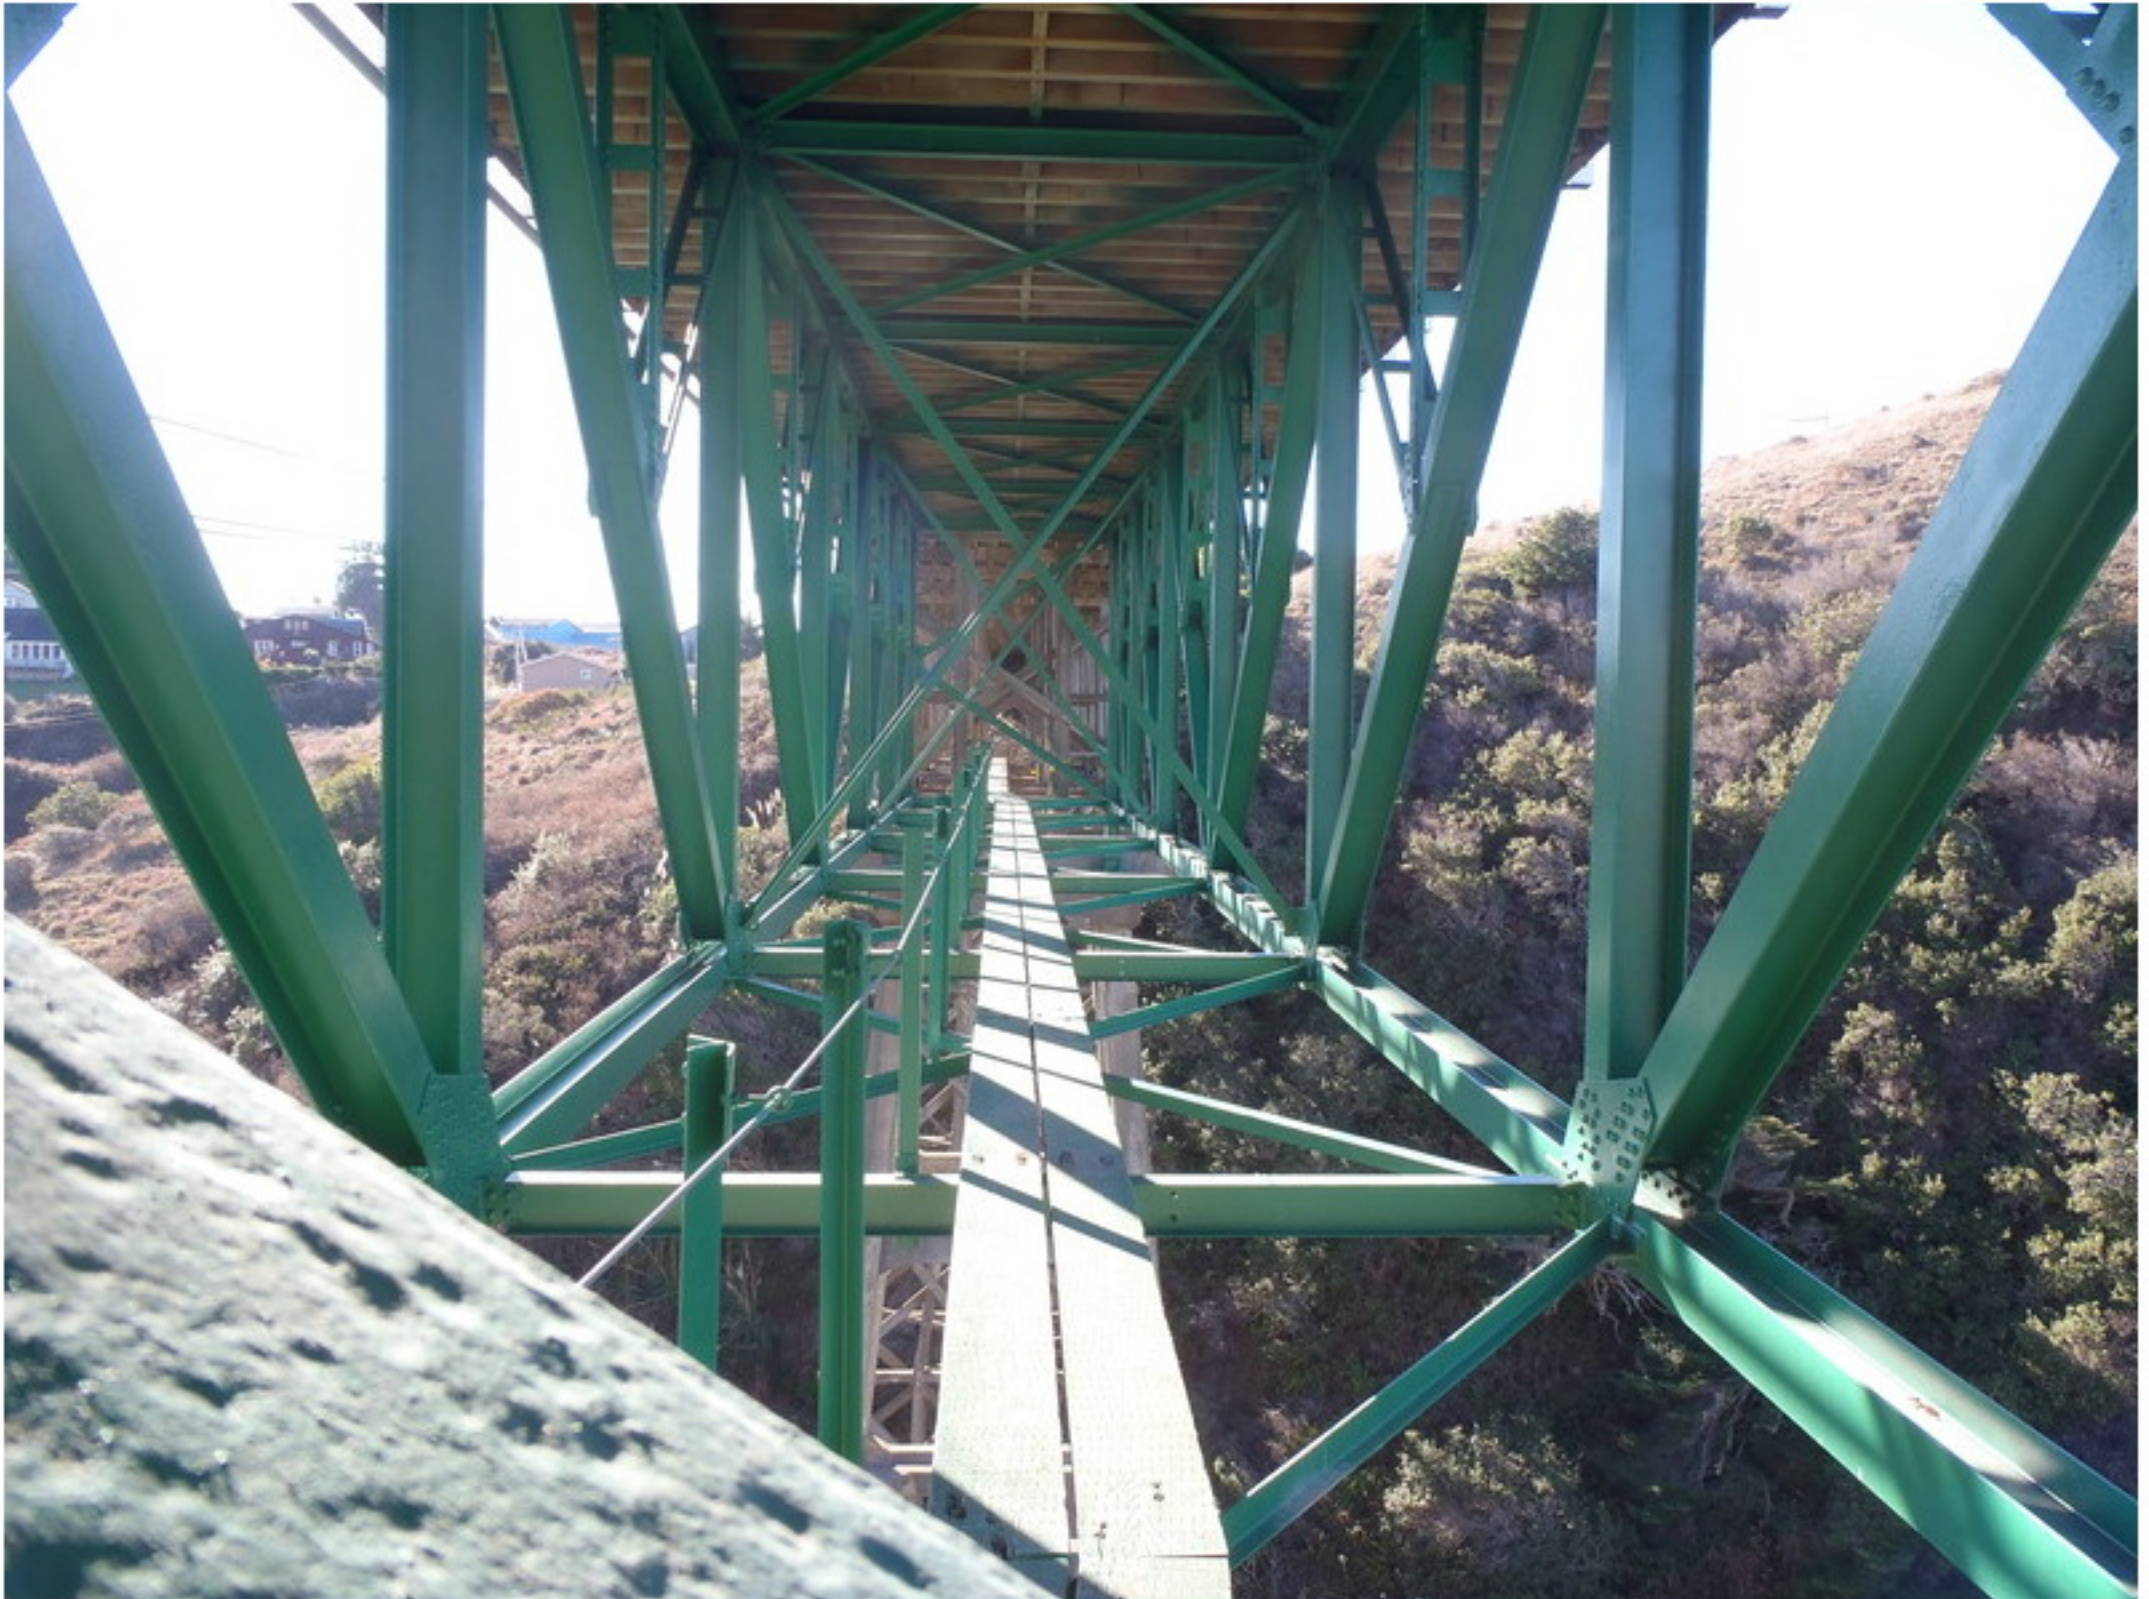
Photo No. 3
Looking south from Bent 13 at recently painted steel members of the main span deck truss

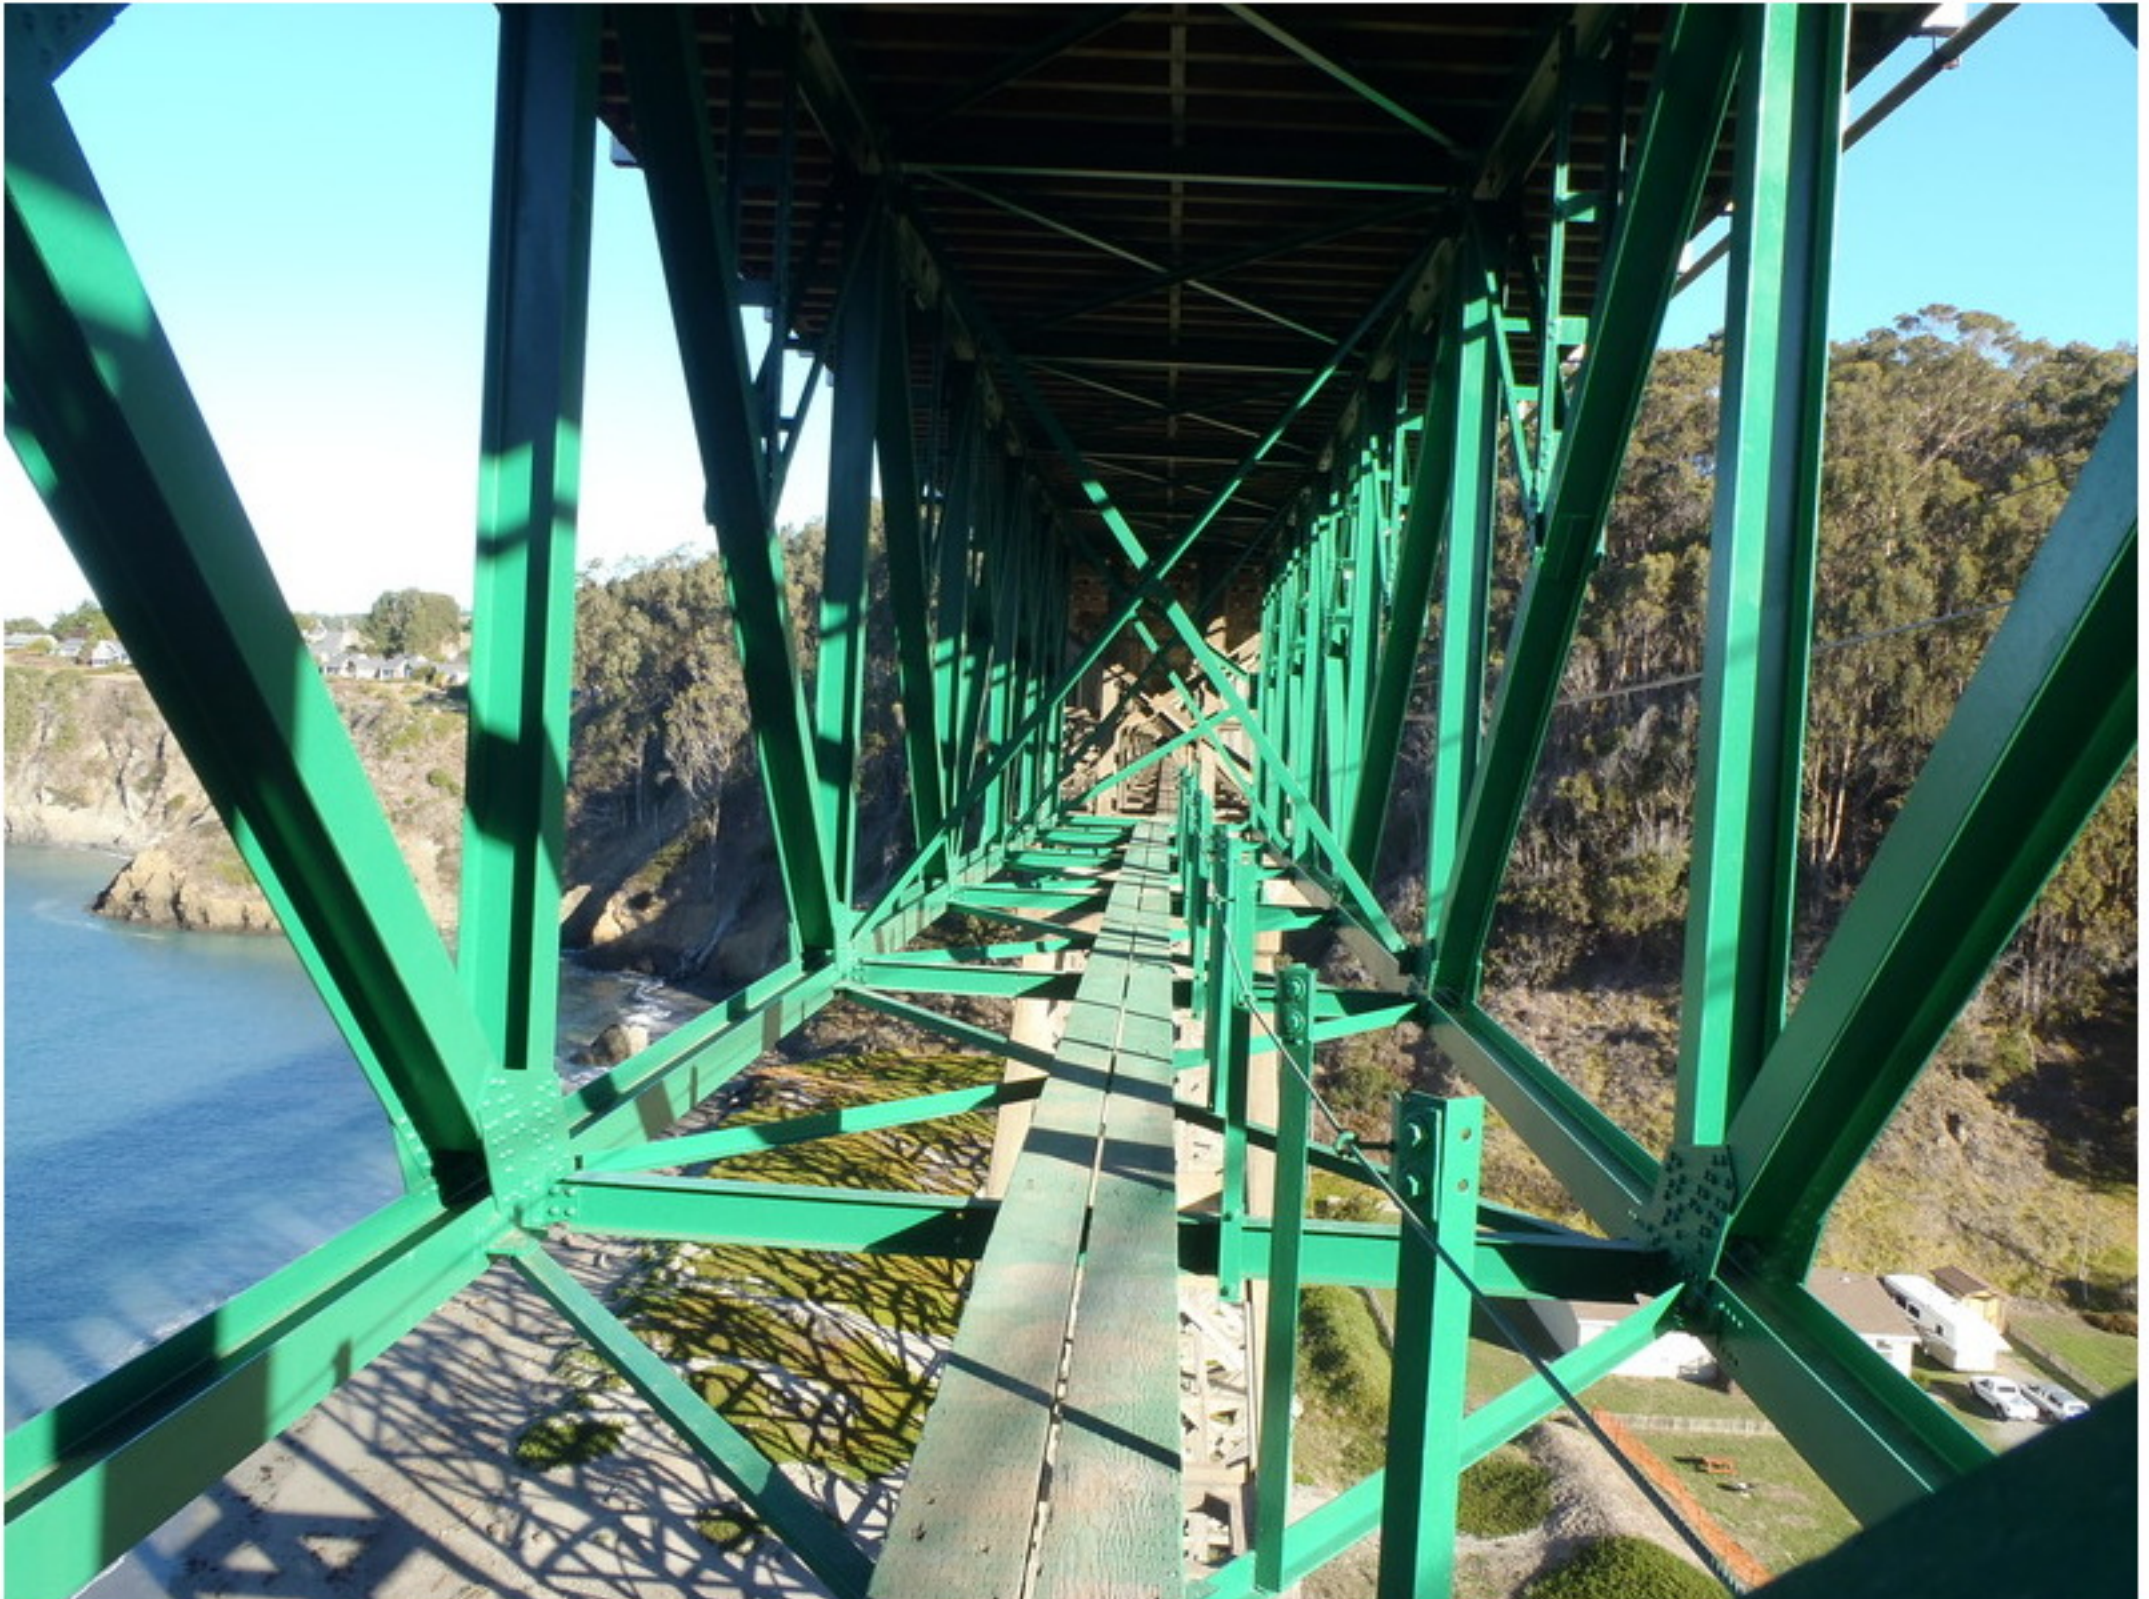
Photo No. 4
Looking north from Bent 12 at recently painted steel members of the main span deck truss

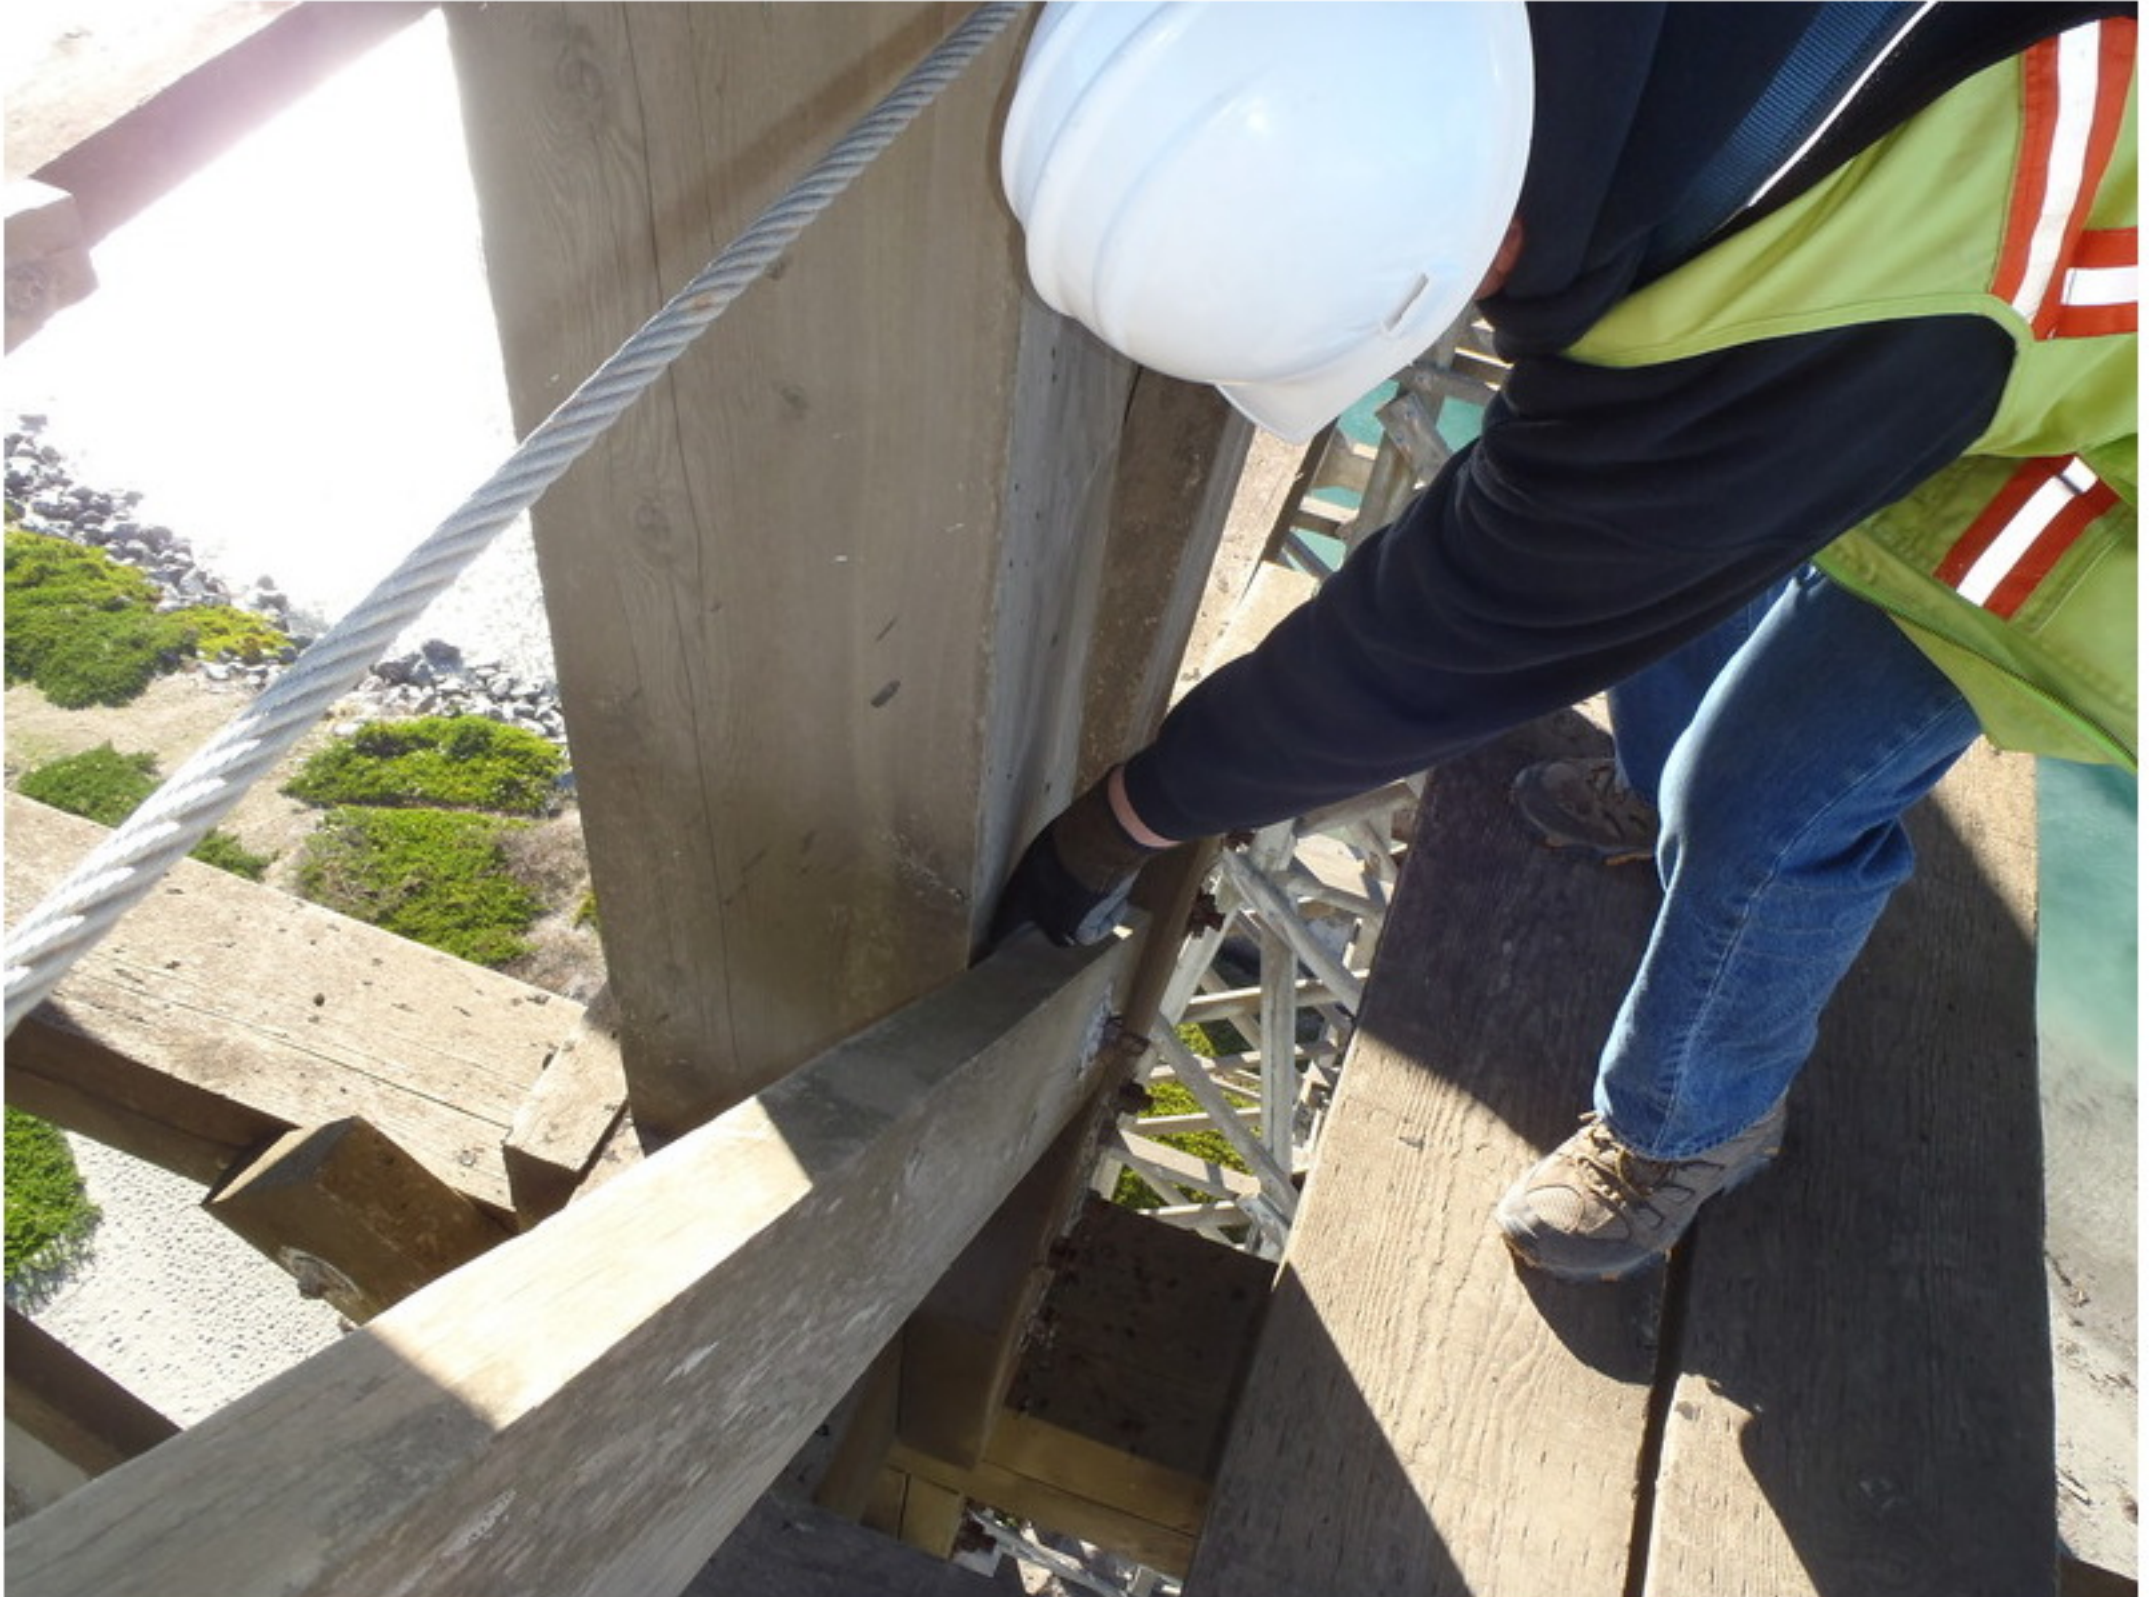
Photo No. 5
Looking down at location of broken bolt at Bent 17 where diagonal brace meets Column 3

Continue the ongoing program of replacement of timber fasteners. Remove and replace the bolted connections and hardware (threaded rods, malleys, nuts, splice plates/straps, scabs, etc.) throughout the entire timber sub-structure.

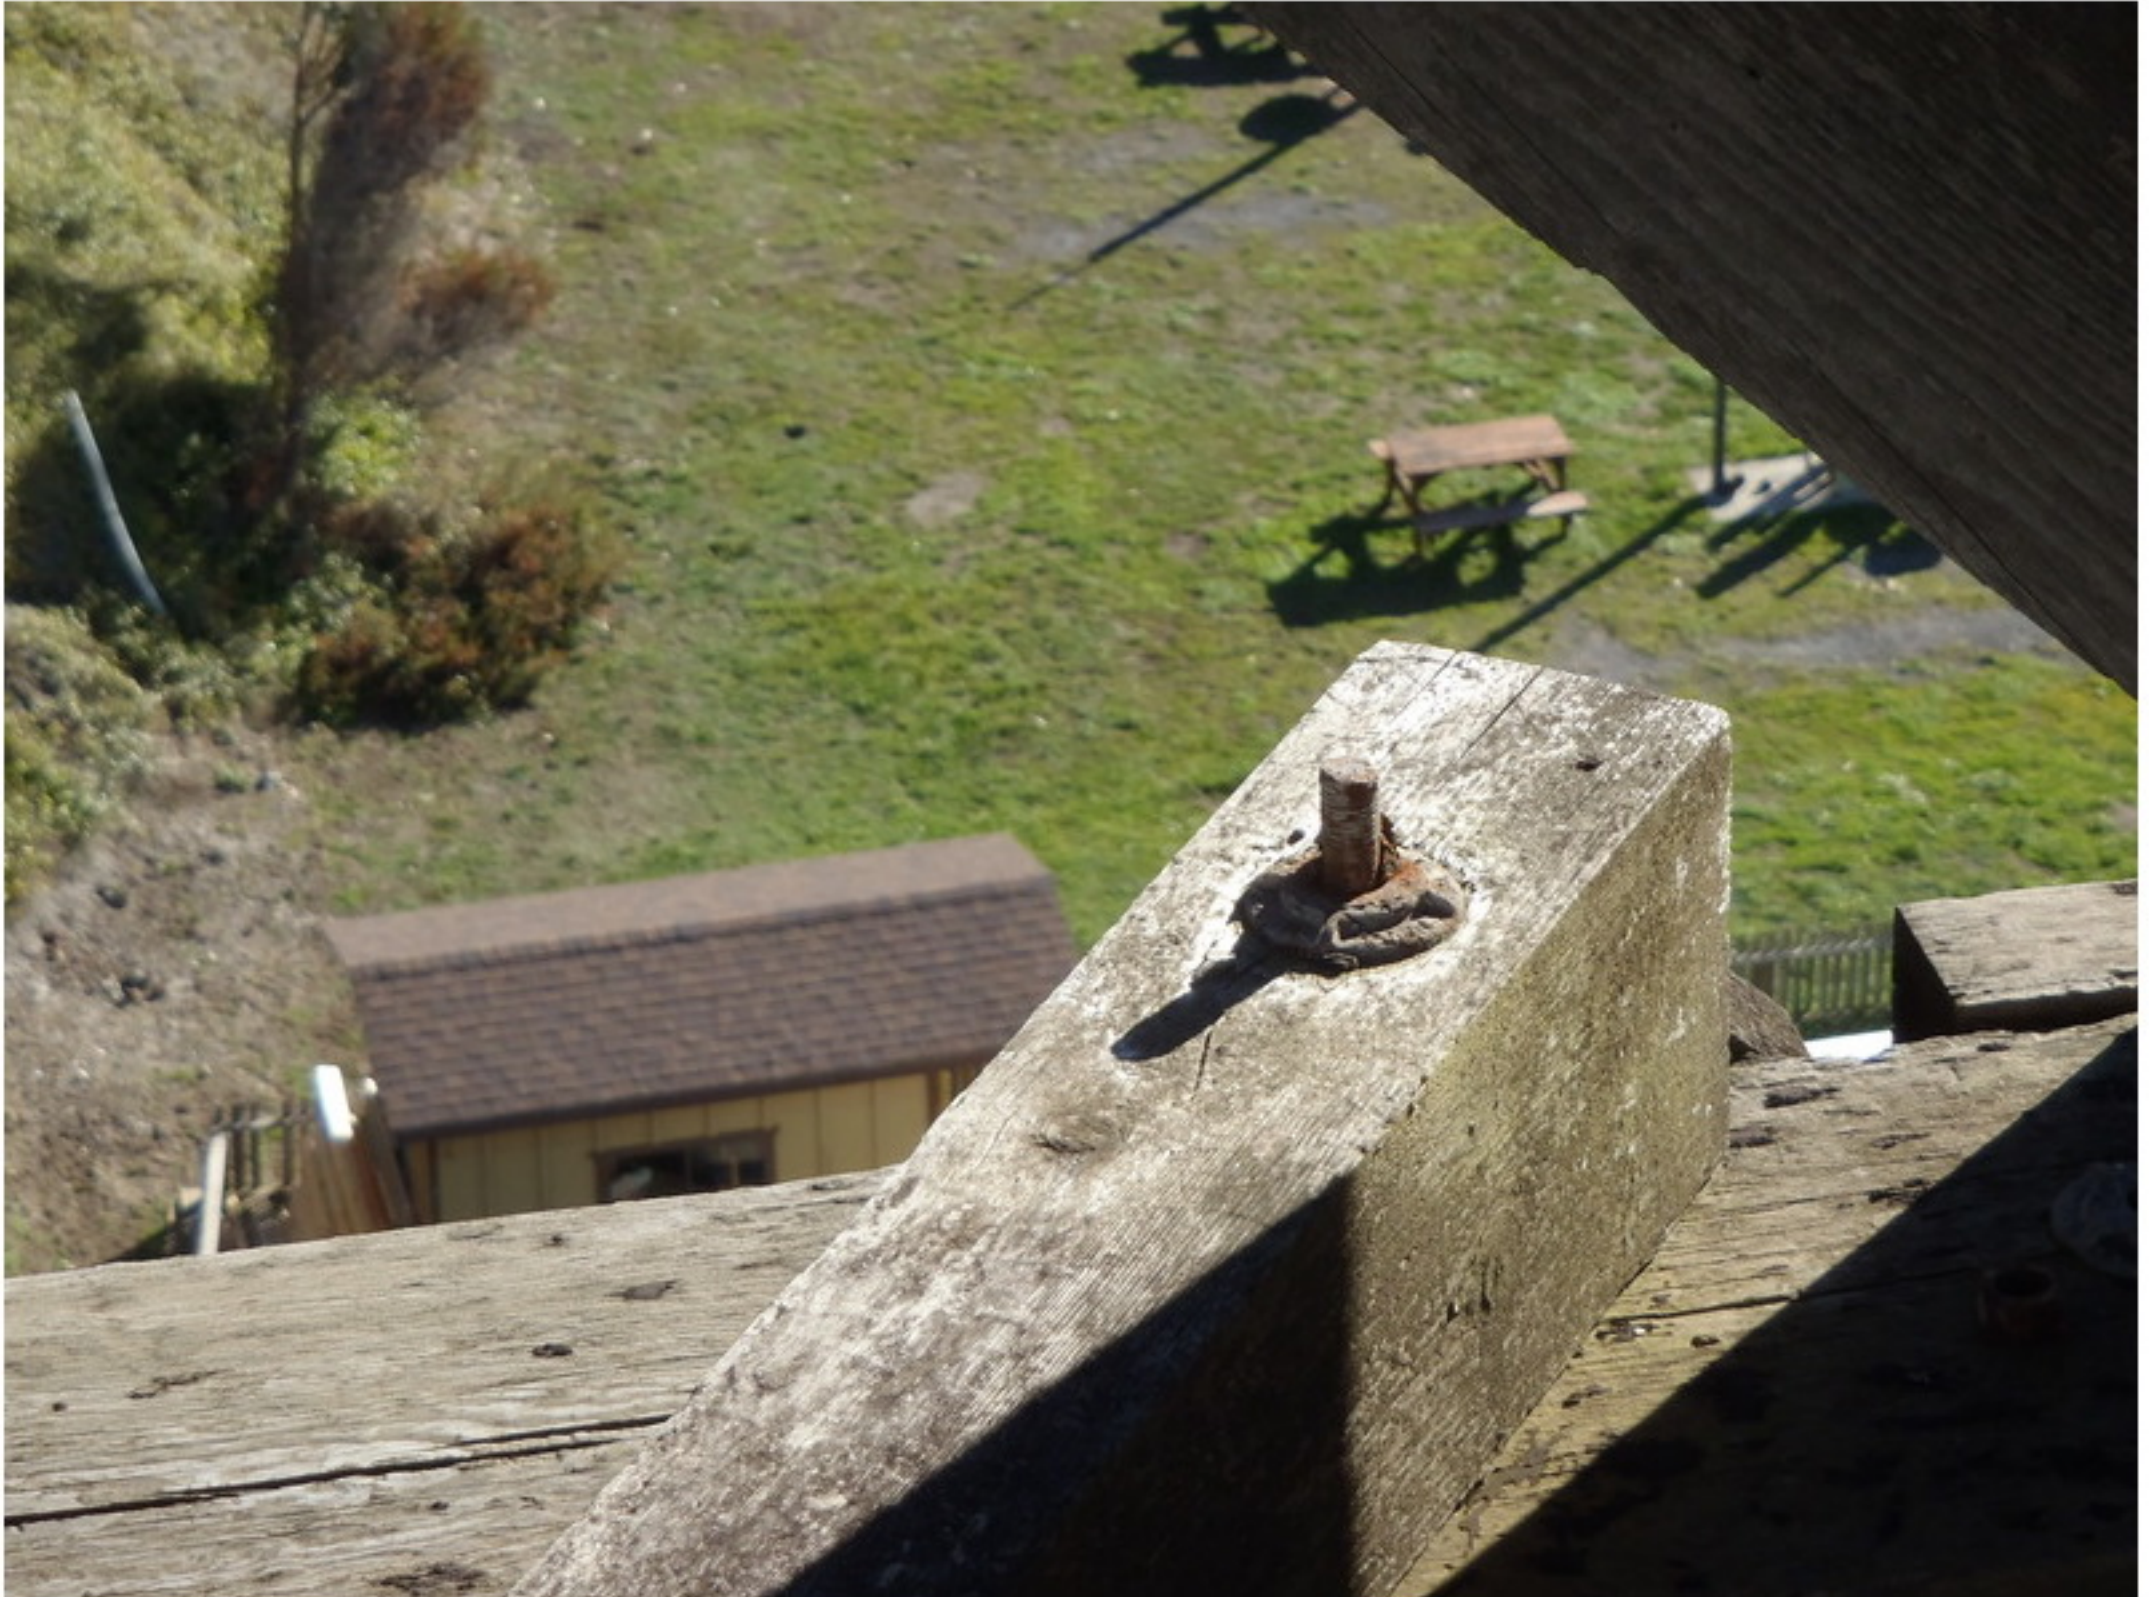
Photo No. 6
Looking easterly at bolted connection adjacent to Column 4 in Bent 23- nut is missing
